SESPE CREEK OVERFLOW  
RAILROAD BRIDGE REPAIR

**EXHIBIT D**  
BIOLOGICAL RESOURCES ASSESSMENT  
AND  
JURISDICTIONAL DELINEATION REPORT

# Biological Resources Assessment and Jurisdictional Delineation Report

*Ventura County Transportation Commission's Santa Paula Branch Line Sespe Creek Overflow Railroad Bridge Repair Project*

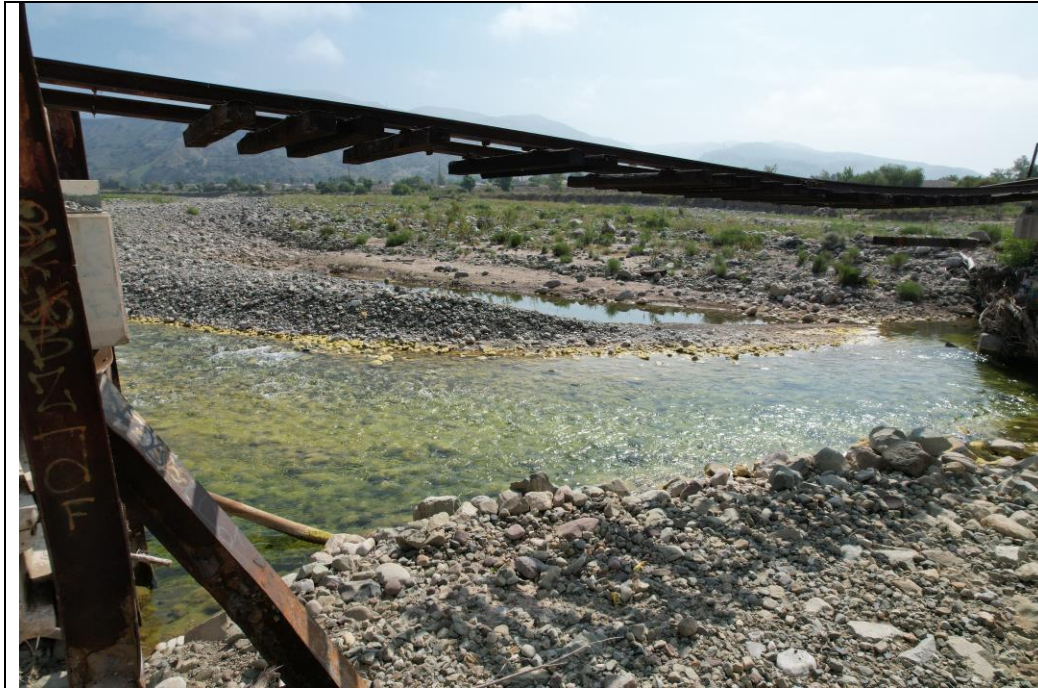
Photo 1. View from damaged abutment looking east

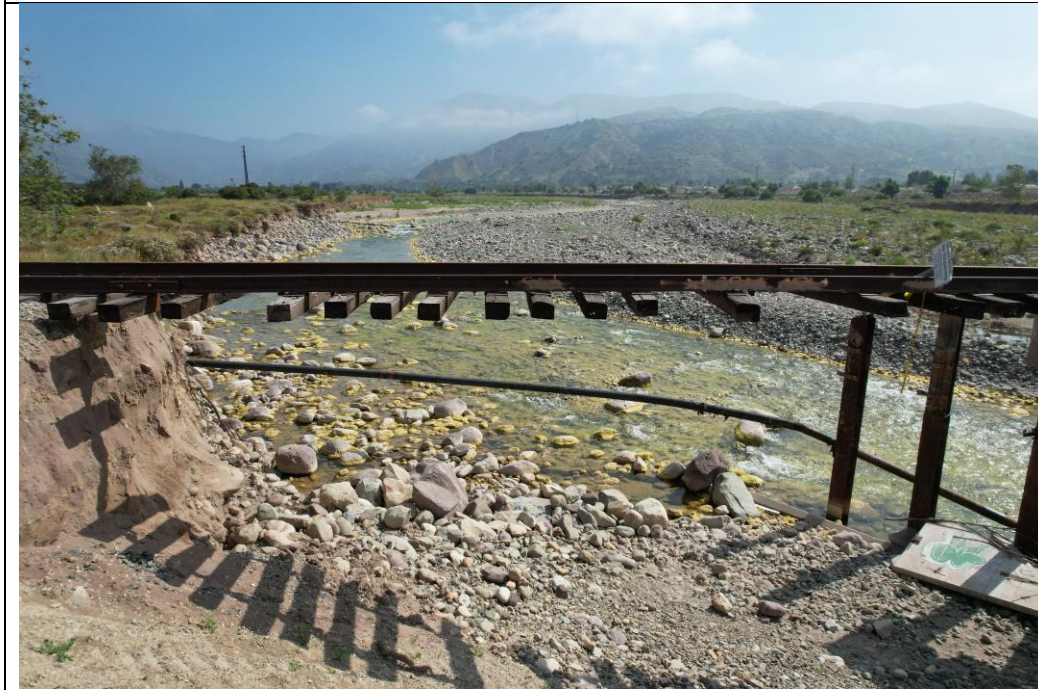
Photo 2. View of 2024 storm damage. Looking East

On January 10, 2023, following a series of large storms that produced extreme sediment and debris laden flows, three span bents were washed out on the western end of the bridge. The rail and attached rail ties were left suspended between the abutment and the 4th bent, leaving the bridge and rail line out of service. In addition to this initial damage, subsequent atmospheric river storms during the winter of 2023-2024 resulted in additional damage to the west railroad bridge abutment culminating in significant erosion behind the west abutment of the bridge. These events were also declared a Federal disaster on April 13, 2024 (DR-4769-CA). The concentrated channel flows resulting from the 2023-2024 storms have pushed the north bank and has now eroded behind the abutment. VCTC has completed emergency erosion protection measures under regional emergency repair permitting in order to prevent further damage during the 2024-2025 storm season.

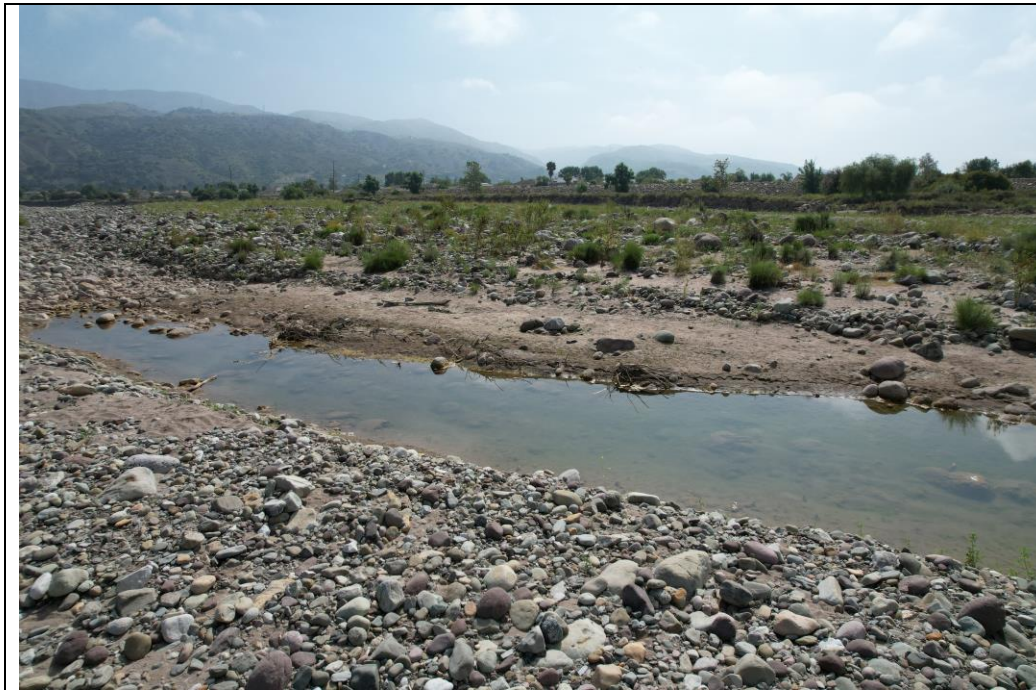
Photo 3. Typical channel view.

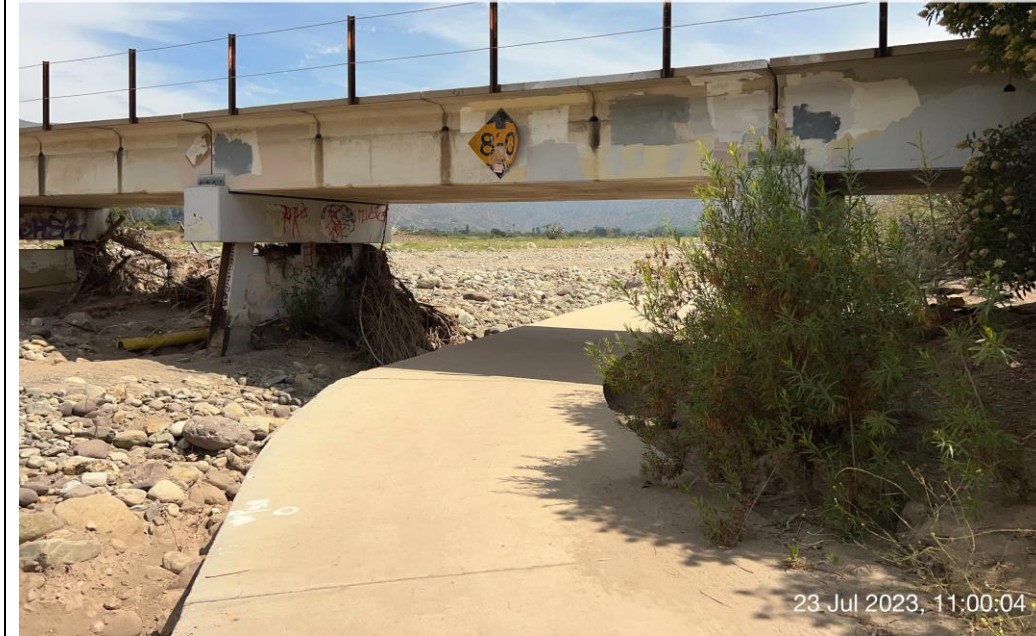
Photo 4. South abutment looking east

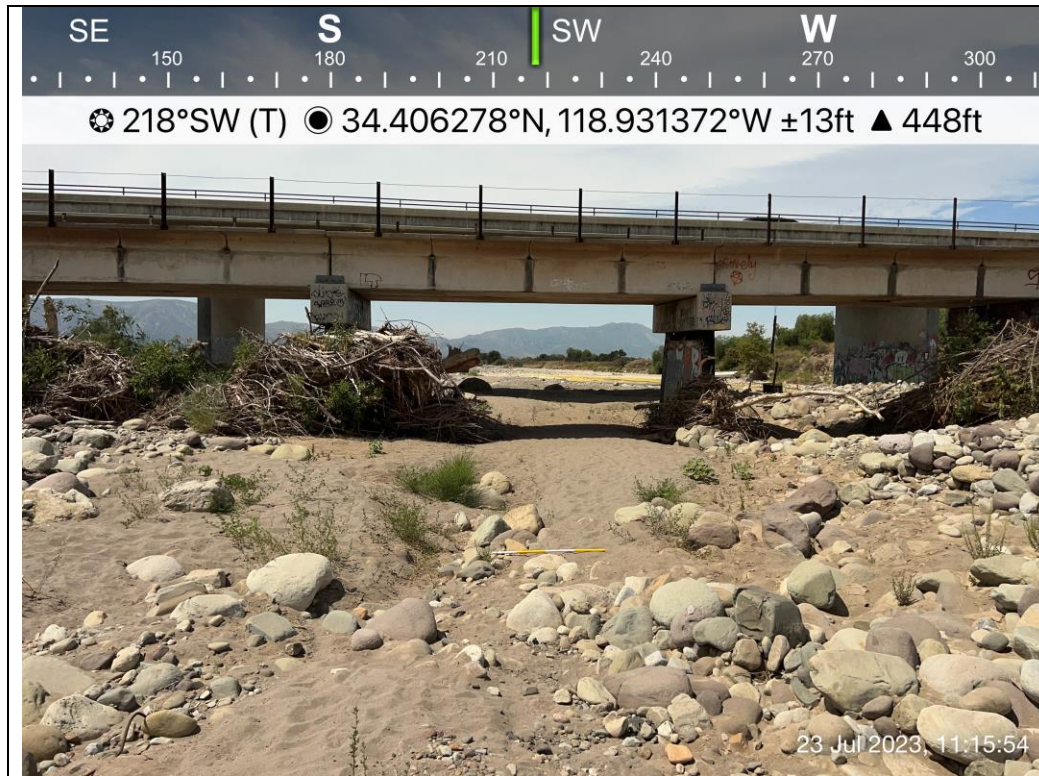
Photo 5. View of debris on undamaged section of the bridge. Looking West

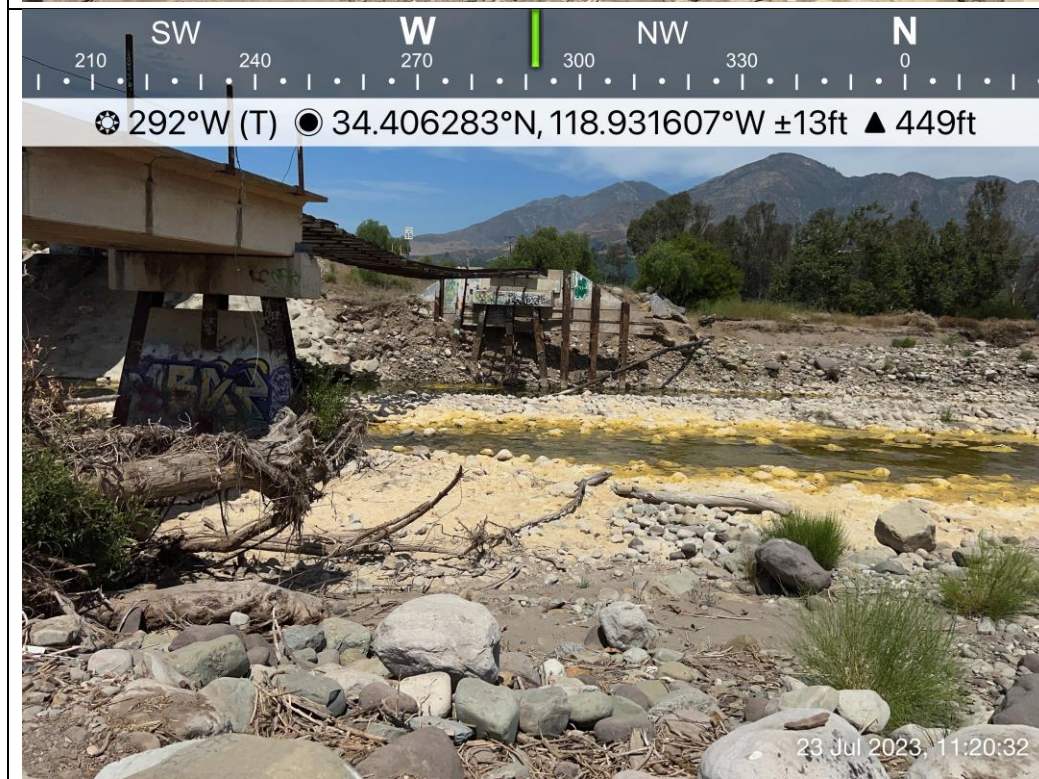
Photo 6. View of damaged bridge looking northerly.

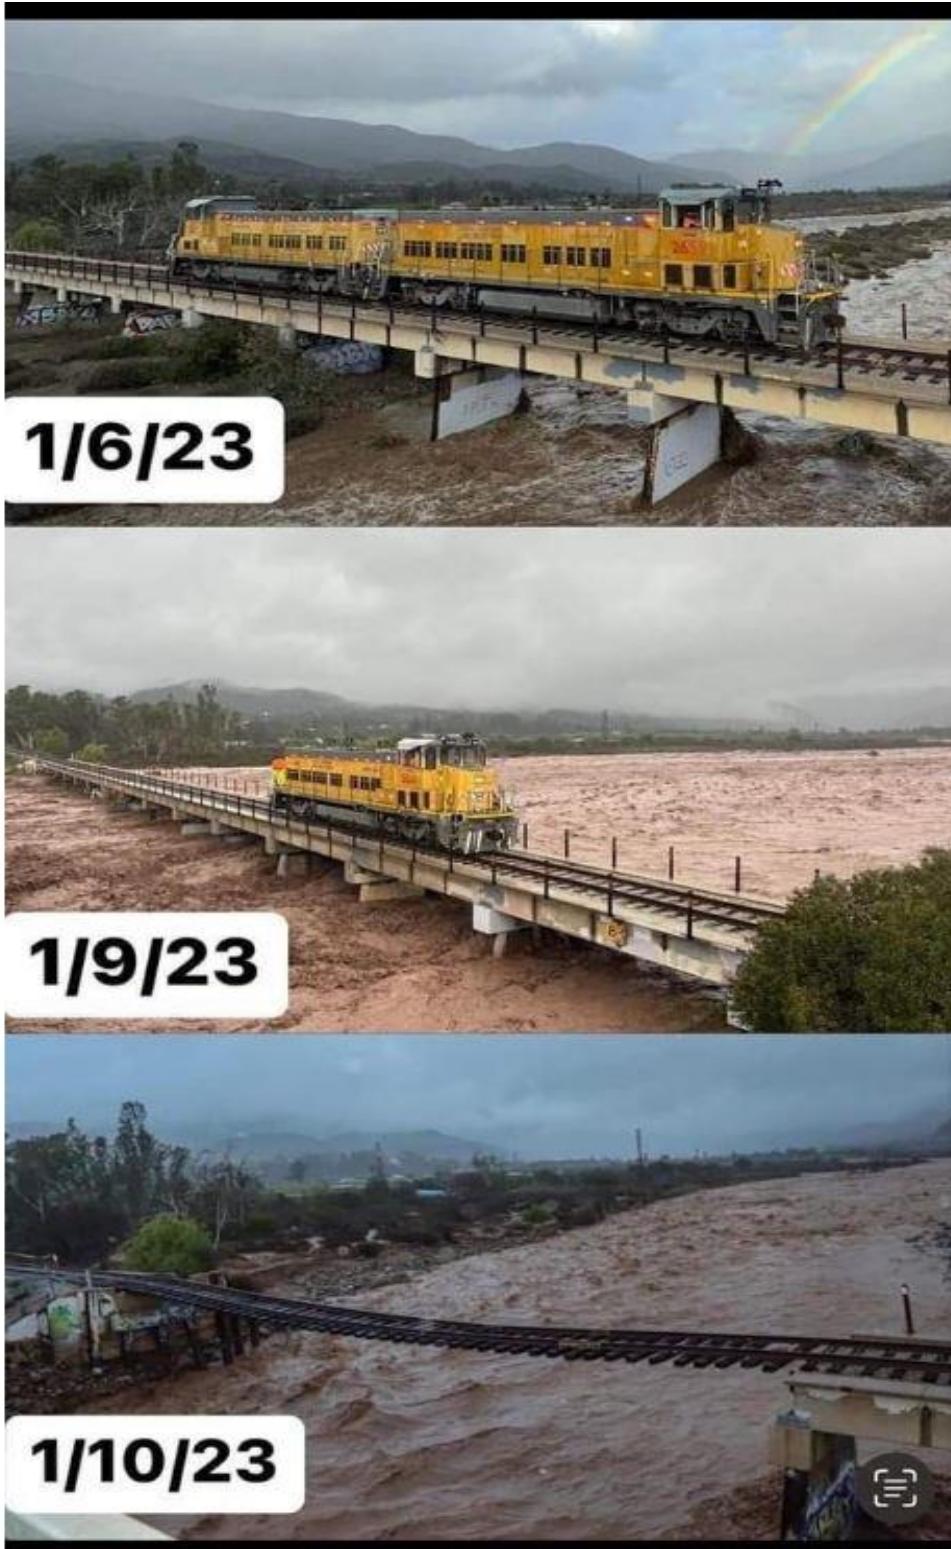
Figure 3. Photographs of VCTC Sespe Creek Bridge, January 2023.
